Fractography of Advanced Structural Ceramics: Results From The VAMAS Round Robin Exercise

Jeffrey J. Swab and George Quinn

ARL-TR-656

December 1994

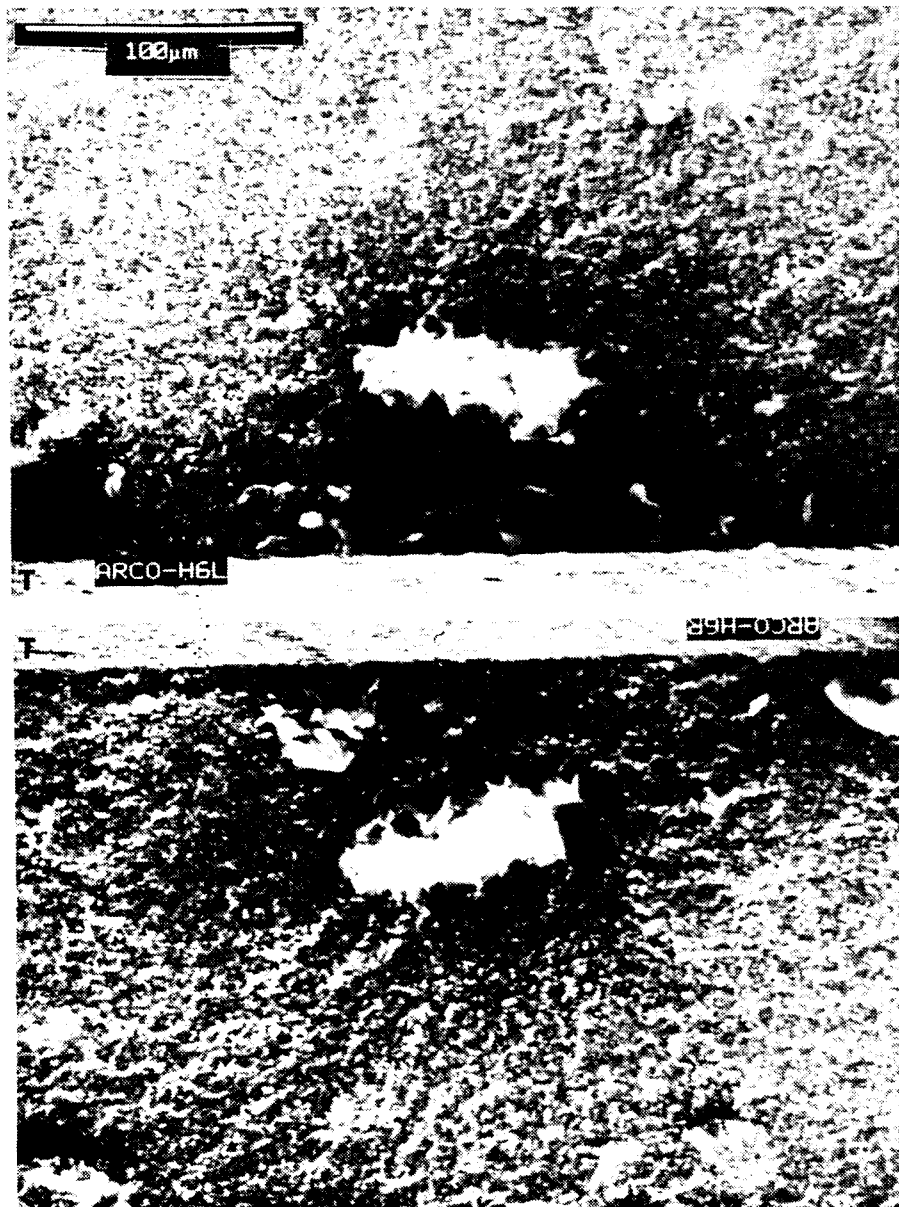
PARTICIPANTS' RESULTS: The participants results are summarized in Table 2.1. Only five (8, 9, 10, 13, and 16) of the 17 participants felt that the origin was a large grain(s). Participants 1 and 3 believed that large grains were part of a combined origin. A variety of other identities were also given. All but six of the participants agreed with the organizers' characterization of the location of the

Figure 2.1.1. Example of Large Grains in Specimen 1: Alumina/SiC (whiskers). Mating halves of the primary fracture surface are shown. "T" denotes the tensile surface.

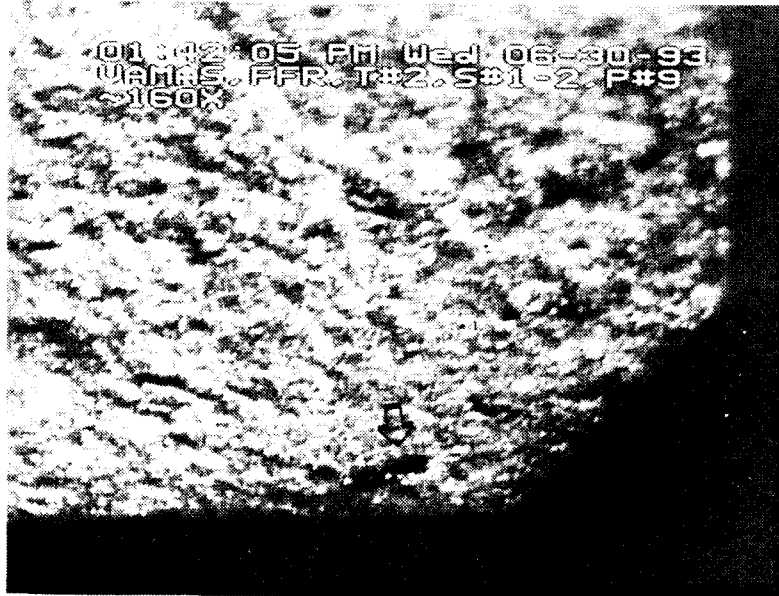
Figure 2.1.3. Optical photograph of alumina grains as the fracture origin in specimen #1. Origin appears as a dark spot when viewed optically. (Arrow added by the organizers.)

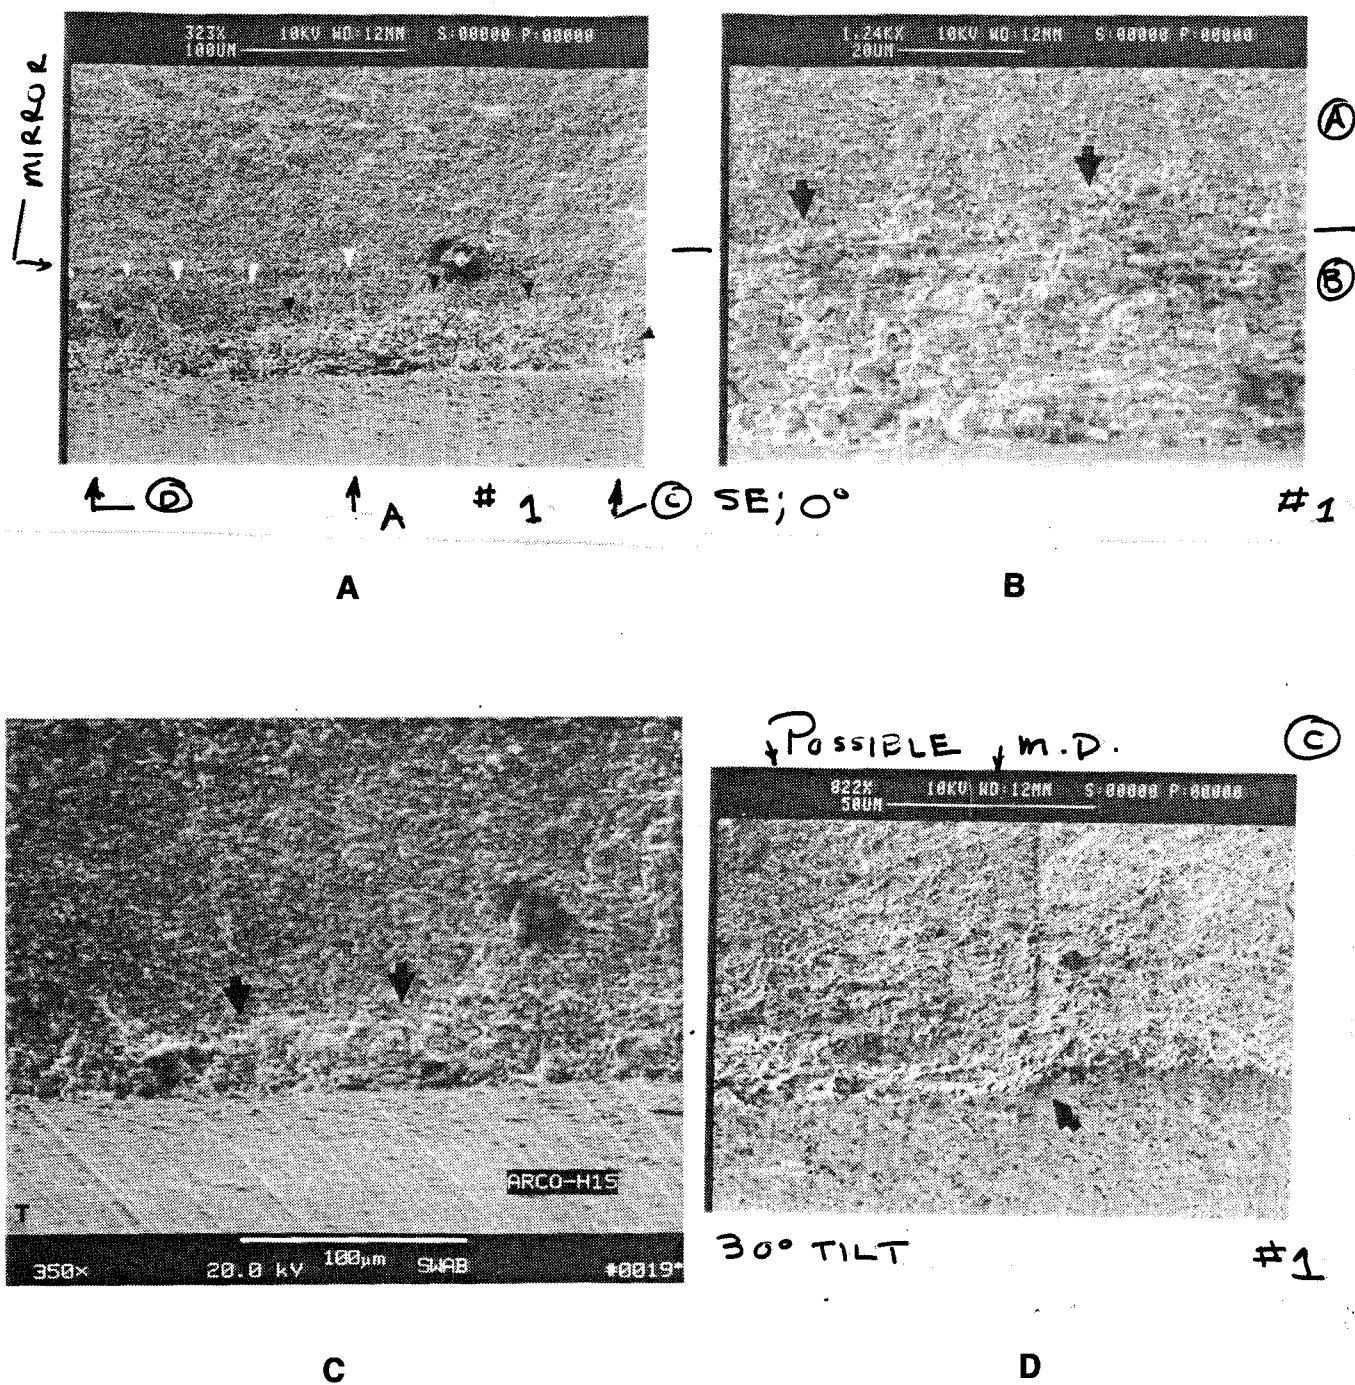
Figure 2.1.4. Photographs of large grain origin in specimen 1 from participant 4. A) and B) are the participants' photographs. Large grains can be seen in B). C) Organizers' photograph. "T" denotes the tensile surface. D) Participants' photograph of the possible machining damage. (Arrows in B and D were added by the organizers. Handwritten notes on A), B) and D) are the participants.)

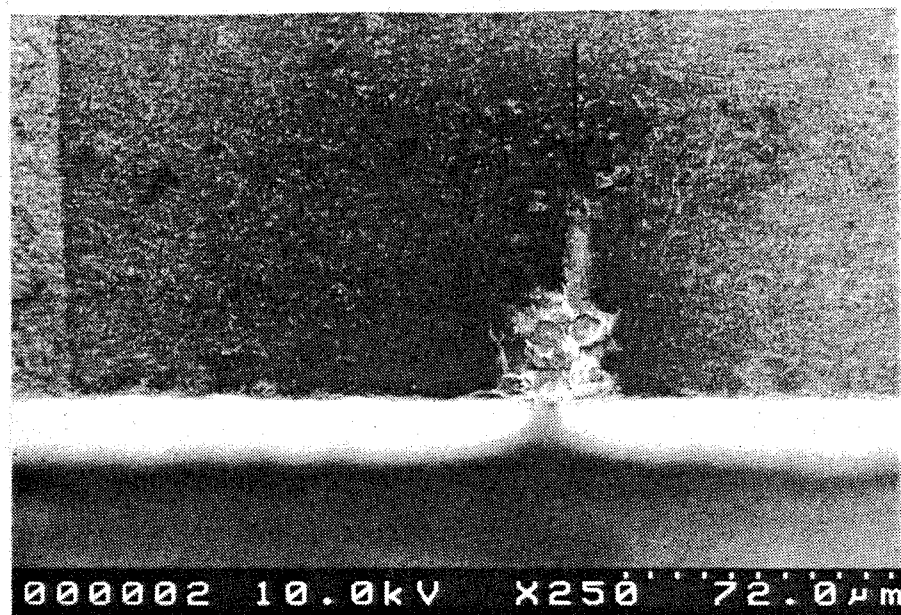
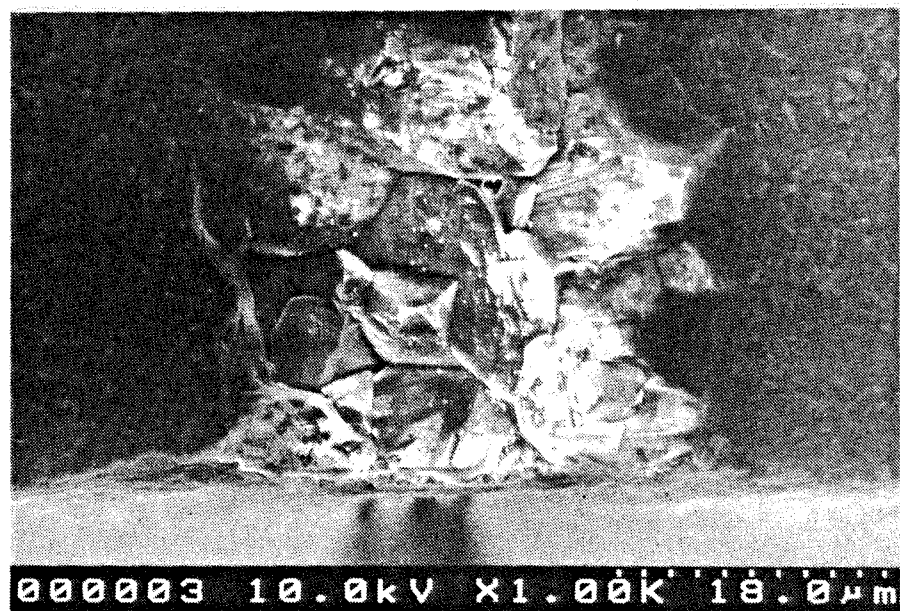
Figure 2.1.5. Two of participant 18's photographs of the origin in specimen 1. The origin is clearly located at the surface.

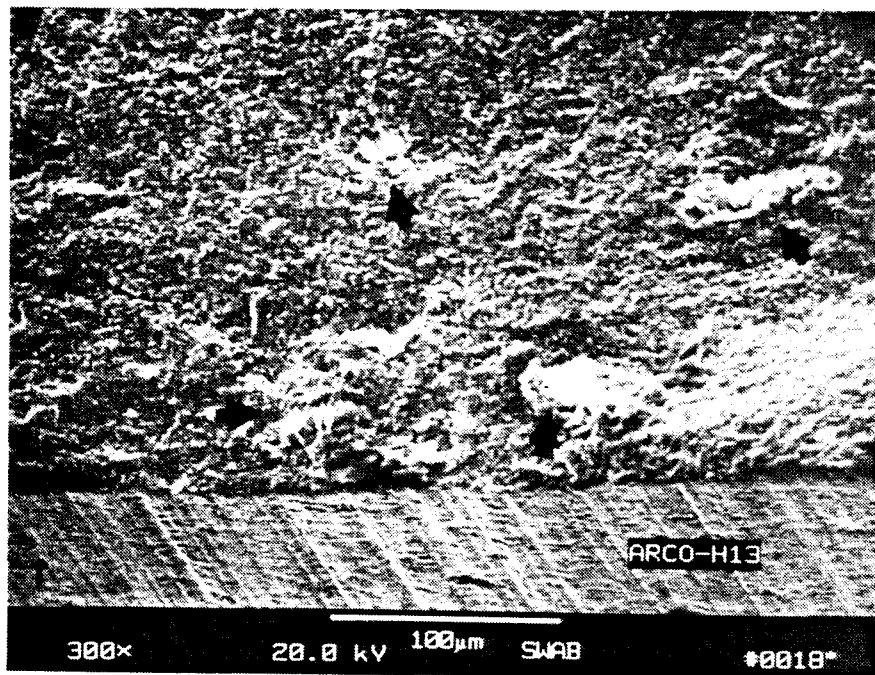
Figure 2.1.6. Organizers' SEM photograph showing several clusters of large alumina grains in specimen 1. "T" denotes the tensile surface.

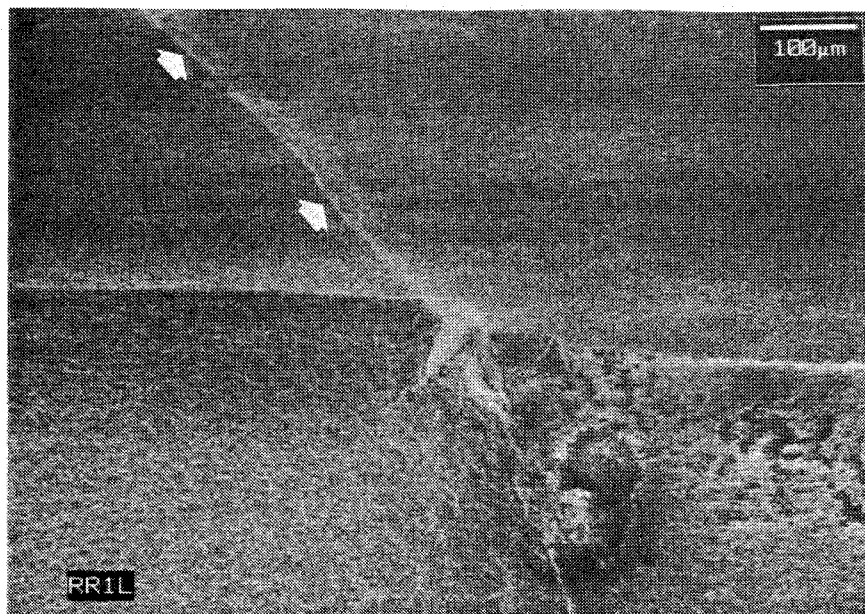
Size - Based on the given material properties and $Y = 1.4$, assuming a semicircular surface crack, the origin size should range from 38 μm ($\sigma = 466$ MPa) to 273 μm ($\sigma = 173$ MPa). It should be noted that the width of the gouge was approximately 10-30 μm . The gouge itself is too small to be the origin. Therefore, there must be subsurface cracks, similar to machining damage, associated with the gouge. Over half of the participants reported a value within the origin size range while several others were close to this range and four did

Figure 2.2.1. Example of Handling Damage in Specimen 2: Alumina. "T" denotes the tensile surface.

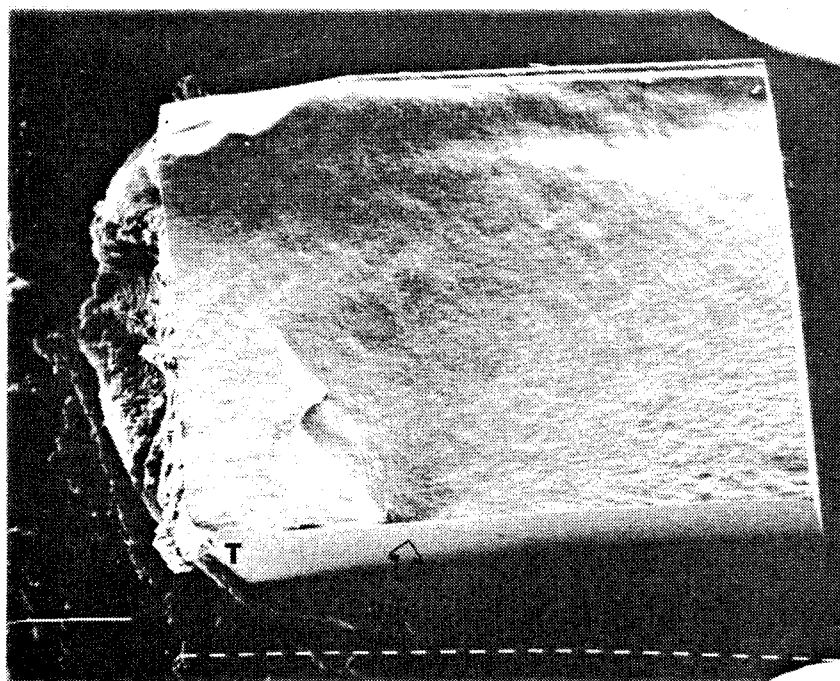
Figure 2.2.2. Participant 16's photograph of one of the mating halves of the primary fracture surface in specimen 2. The arrow was added by the organizers and points out the scratch (HD^S) on the tensile surface (T).

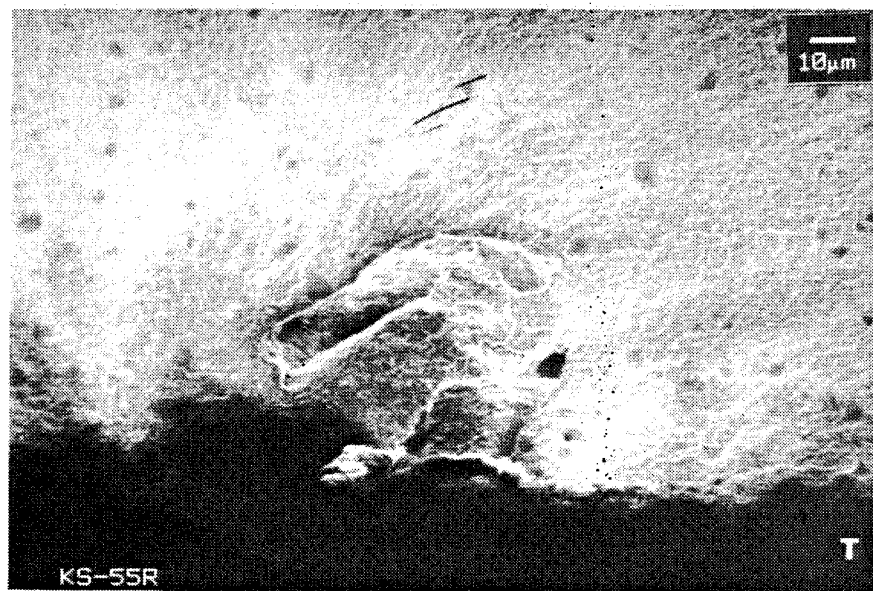
DISCUSSION - Identity - This was the only specimen in Topic #2 that a consensus was reached on the identity of the origin. Since pores are common features in ceramic materials this may account for the consensus. The possibilities why four participants (3, 5, 11 and 18) did not agree with the majority will be discussed.

Figure 2.3.1. Example of a Pore in Specimen 3: Zirconia. "T" denotes the tensile surface.

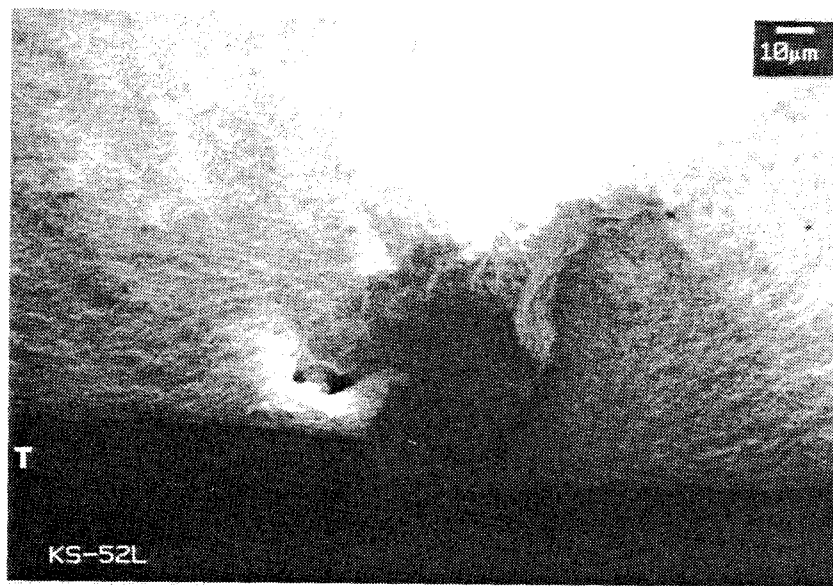
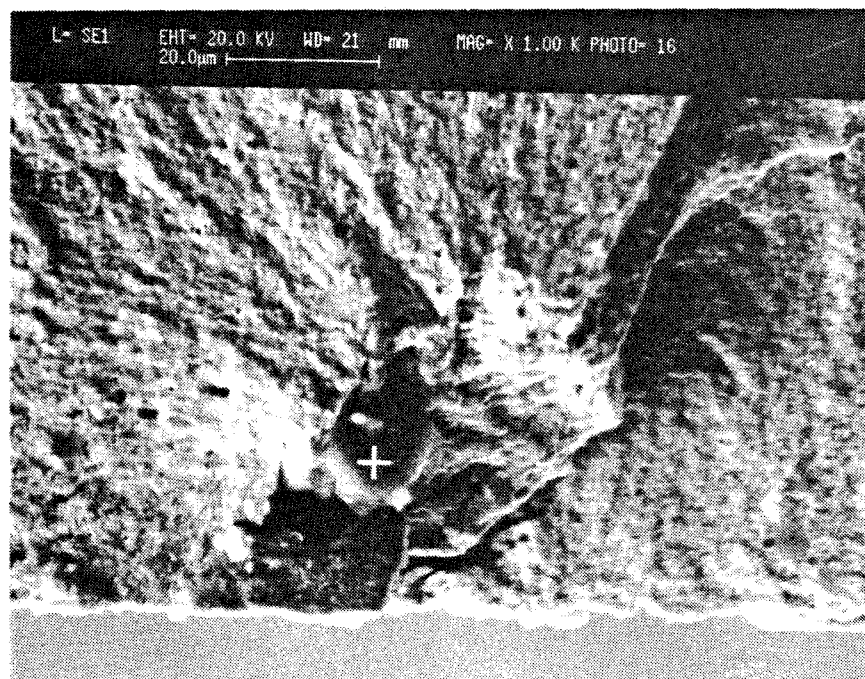
Figure 2.3.2. SEM photographs of the pore in specimen 3 from the set sent to participant 3. A) Organizers' photograph. "T" denotes the tensile surface. B) Participant 3's photograph. "+" indicates the "globule" where EDS was done.

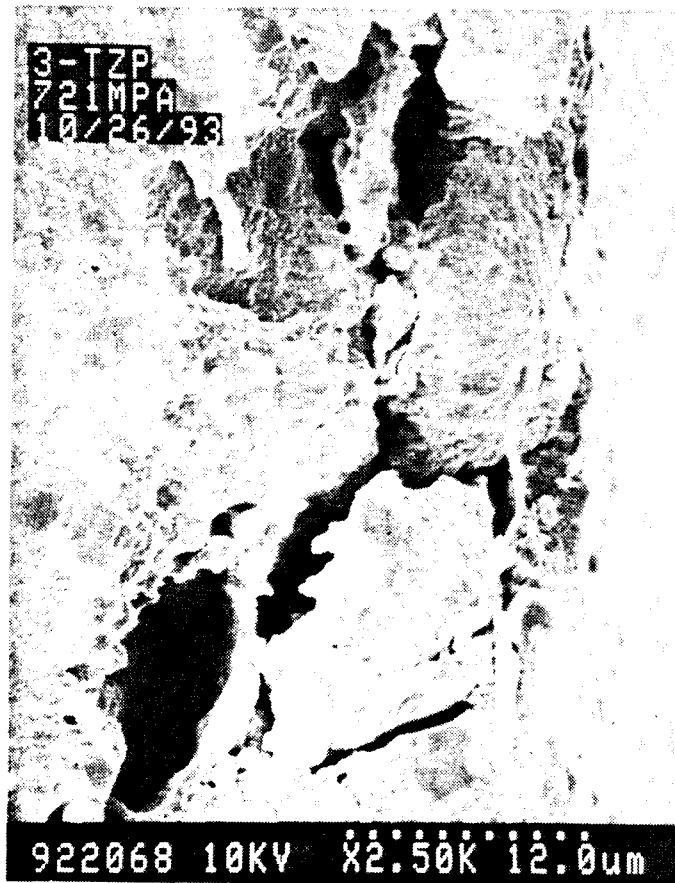
Figure 2.3.3. Participant 5's SEM photograph of the origin in specimen 3. Is this a pore or porous region?

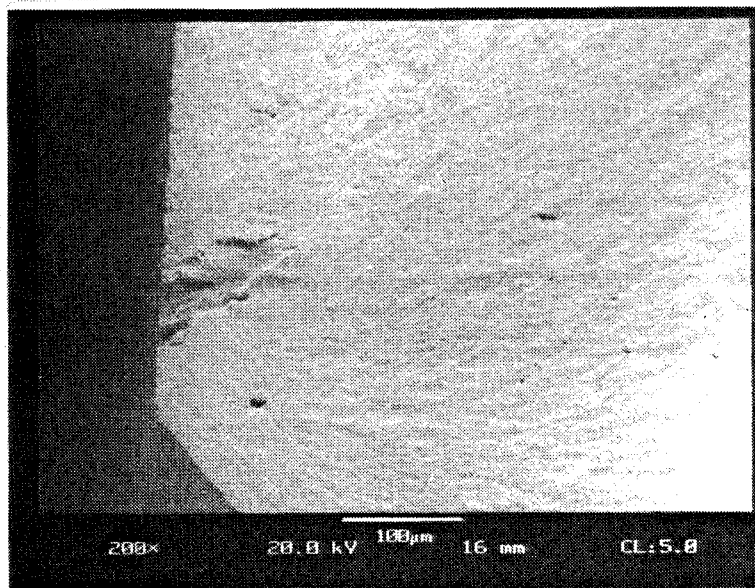
Figure 2.3.5. SEM photograph, from participant 7, of a pore located at the side of the flexure specimen. Appropriate location: Volume (V)*. * located at the side of the specimen approximately 175 μm beneath the tensile surface.

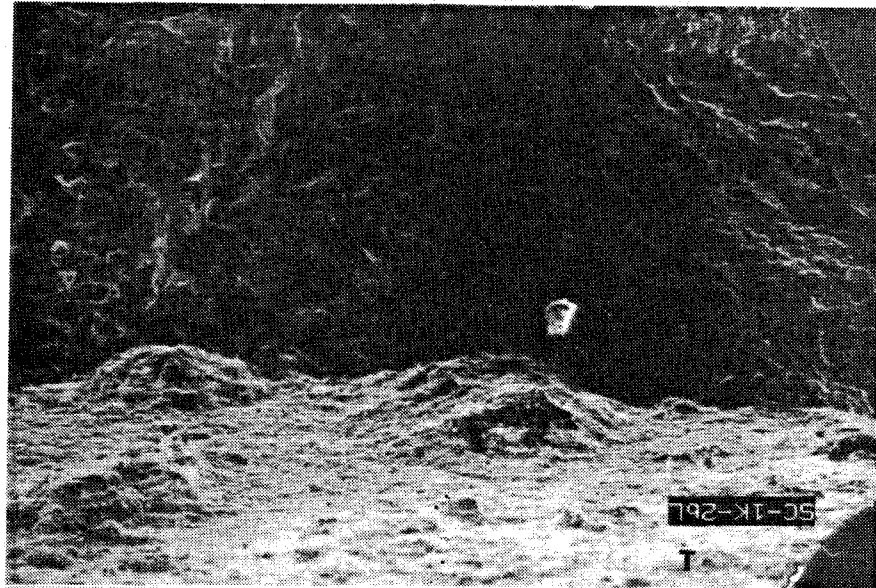
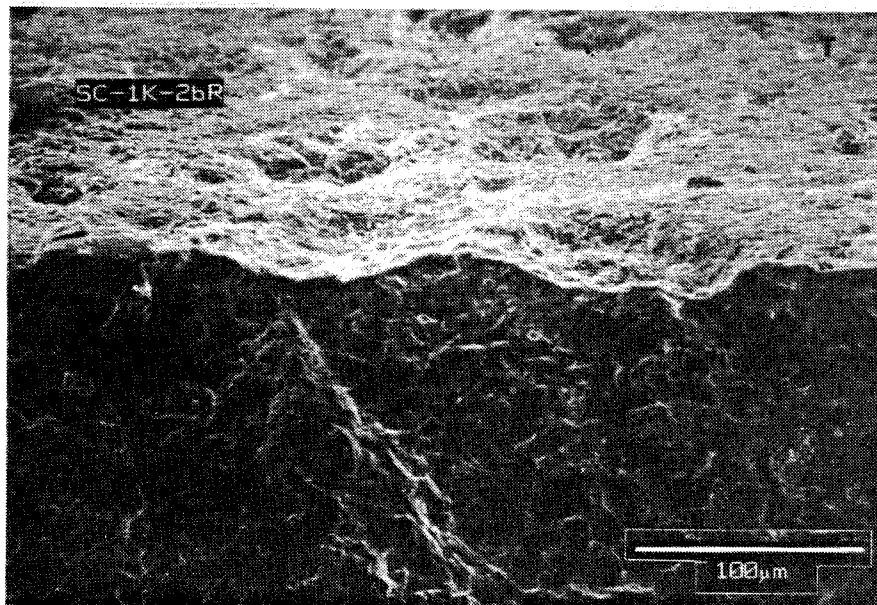
Figure 2.4.1. Example of Pits in Specimen 4: Silicon Carbide. Mating halves of the primary fracture surface are shown. "T" denotes the tensile surface.

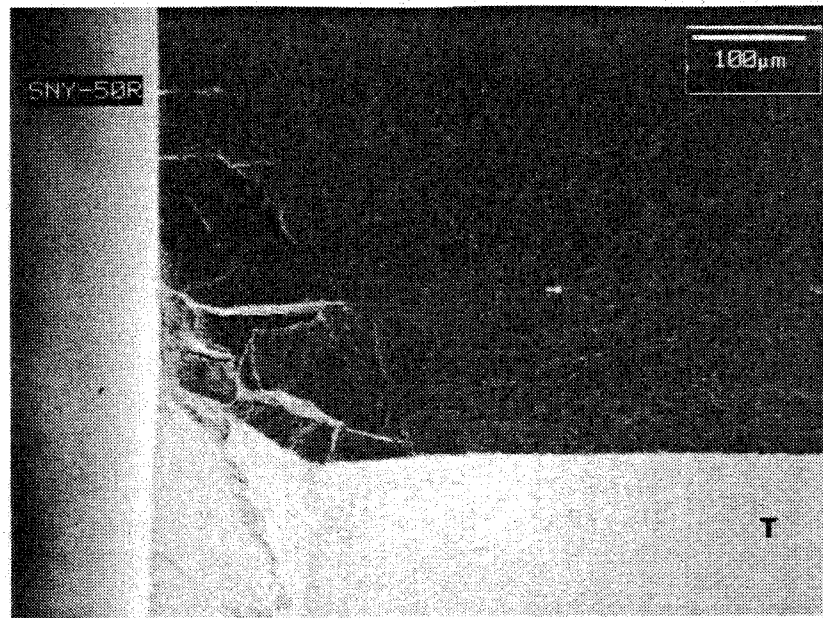
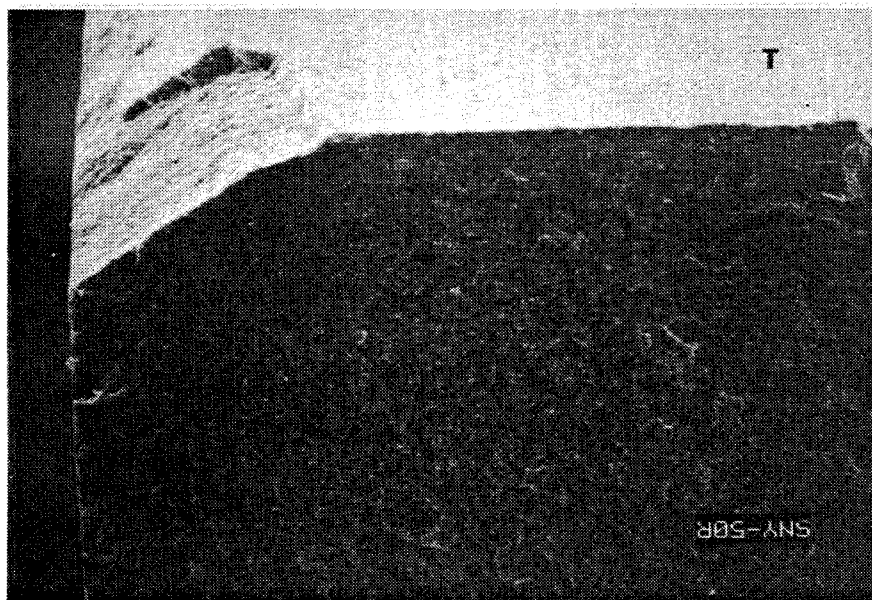
Figure 2.5.1. Example of Machining Damage in Specimen 5: Silicon Nitride. Mating halves of the primary fracture surface are shown. "T" denotes the tensile surface.

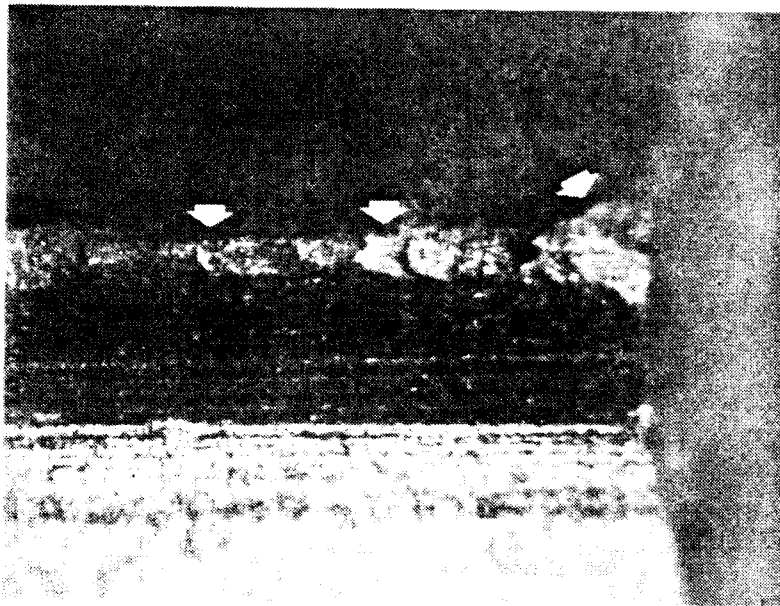
Figure 2.5.2. Optical photograph from participant 4, of machining related chipping on the chamfer of specimen 5. Arrows were added by the organizers.

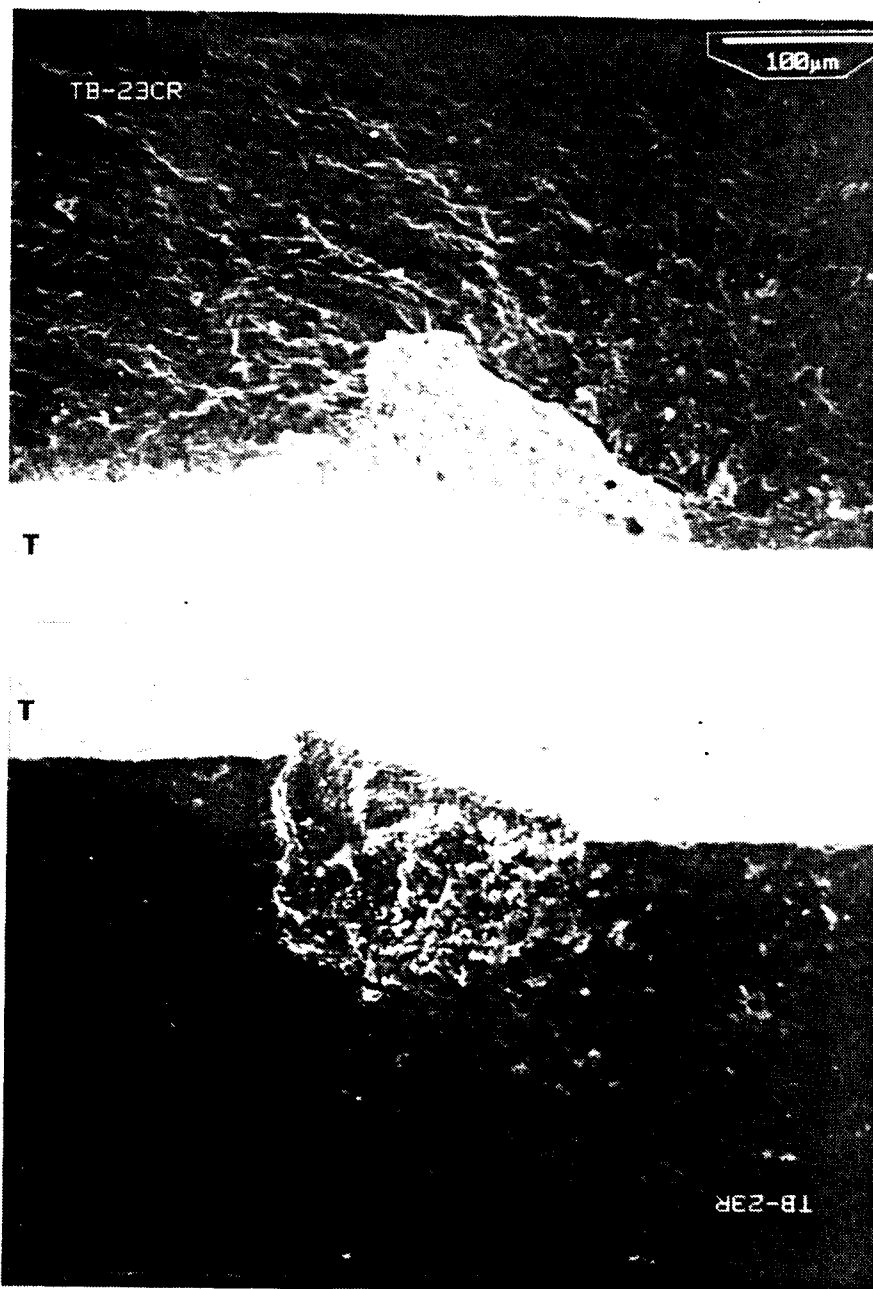
Figure 2.6.1. Example of Porous Seam/Porous Region in Specimen 6: Titanium Diboride. Mating halves of the primary fracture surface are shown. "T" denotes the tensile surface.

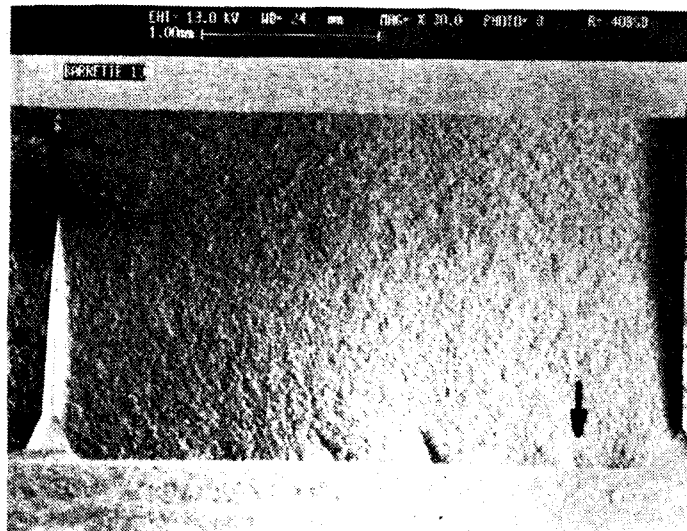
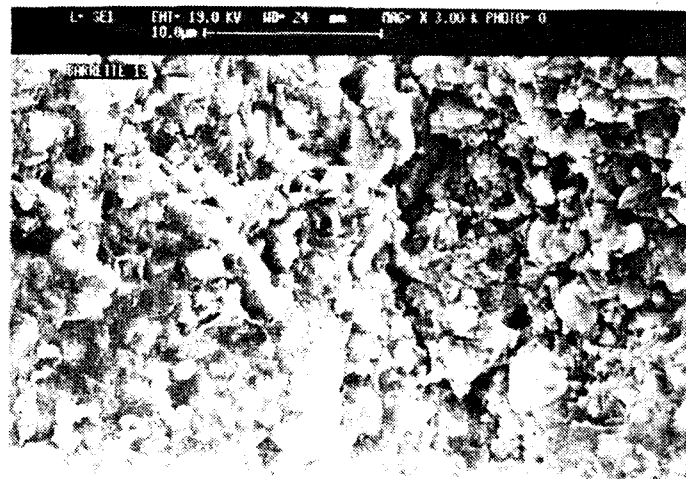
SAMPLE N° 19

MOR = 324.27 MPa

Figure 3.6. Example of an origin in a $\text{Si}_3\text{N}_4/\text{TiN}$ specimen. Labeled by participant 10 as a crack.

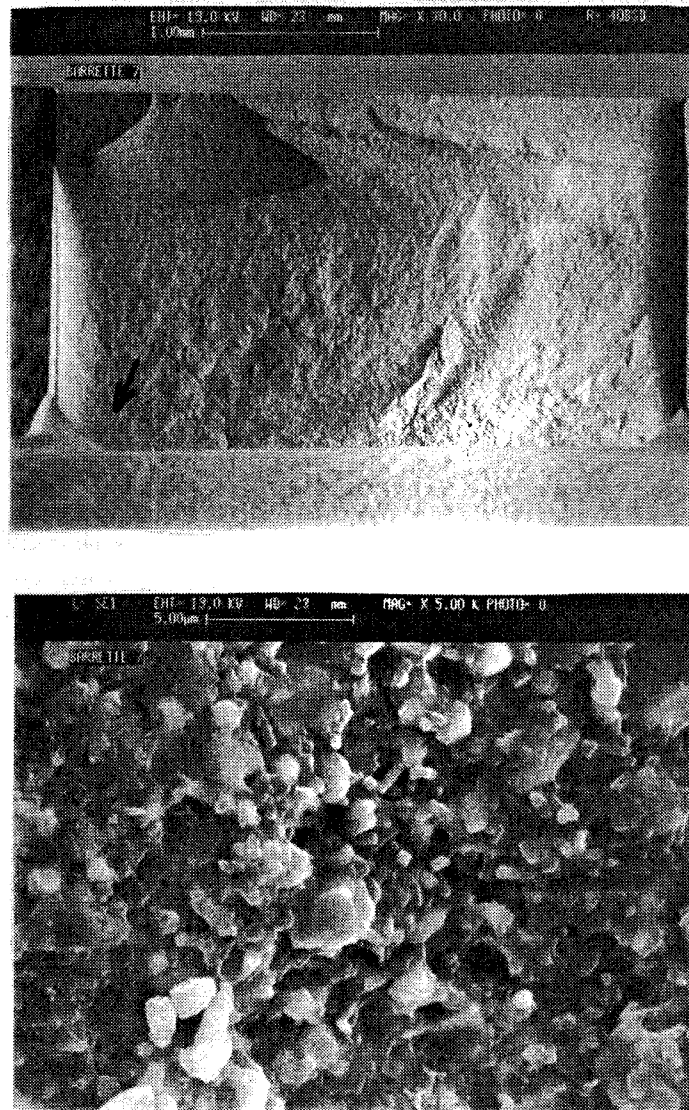
SAMPLE N° 7

Figure 3.7. Example of an origin in a $\text{Si}_3\text{N}_4/\text{TiN}$ specimen. Labeled by participant 10 as a porous region.

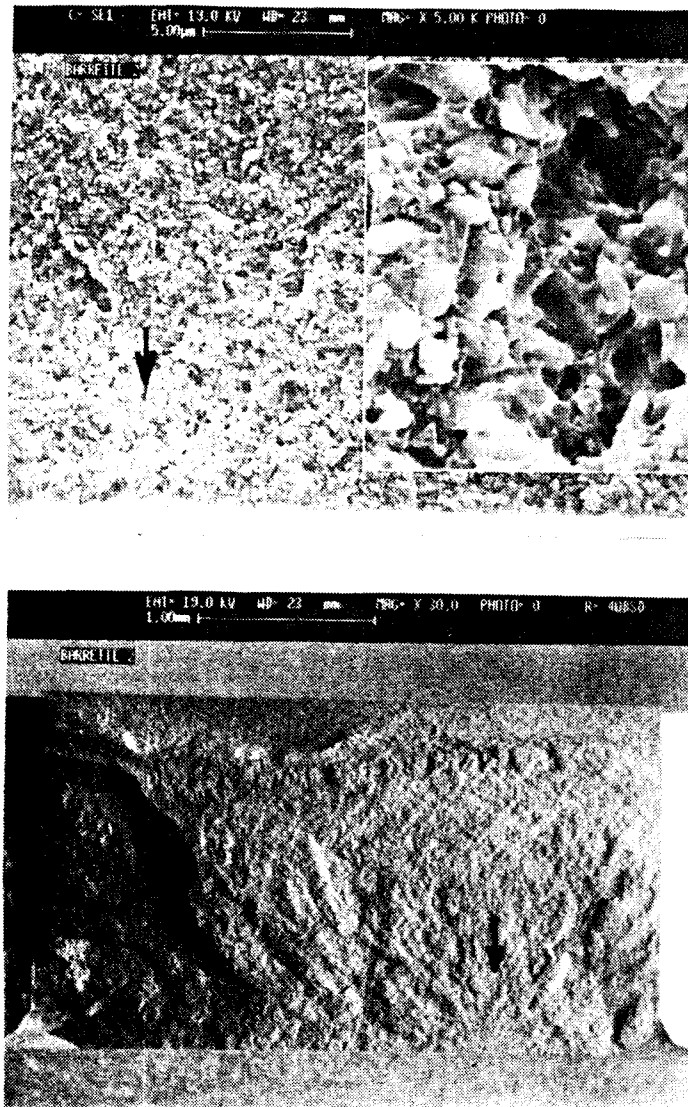
SAMPLE N° 2

Figure 3.8. Fracture origin in specimen 2 for a $\text{Si}_3\text{N}_4/\text{TiN}$ specimen. Labeled by participant 10 as machining damage.
